SPICER SURVEYS

BUILDING CONSULTANCY

1. EXECUTIVE SUMMARY

Site Name	Sample Catholic Primary School Broadway
Date/Time	14/10/2021
Weather	Overcast and Dry
Site Photo

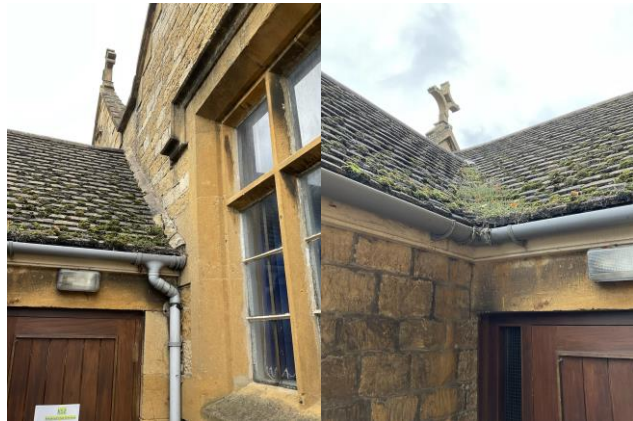
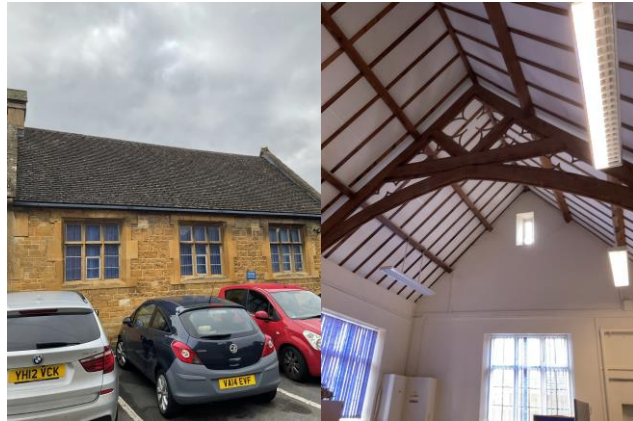
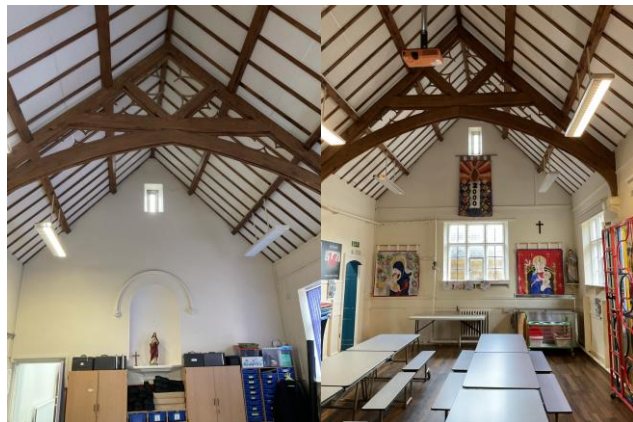
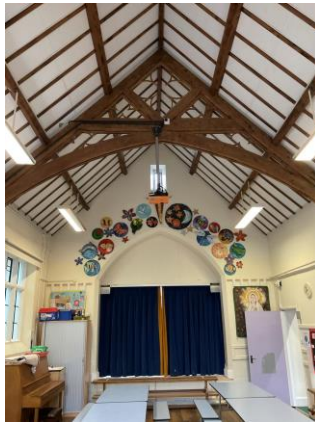
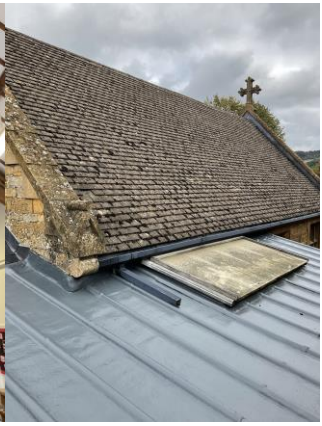
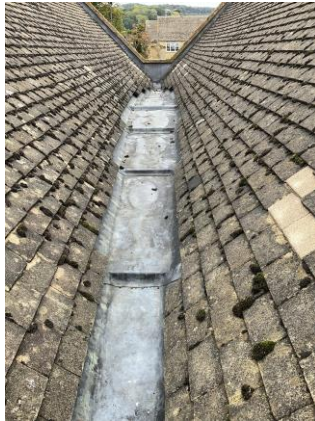
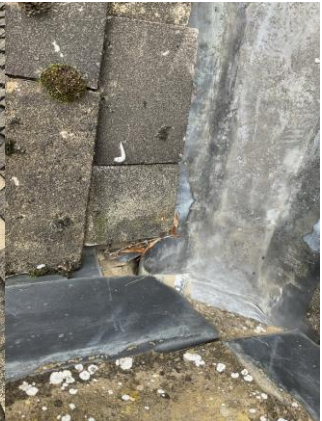
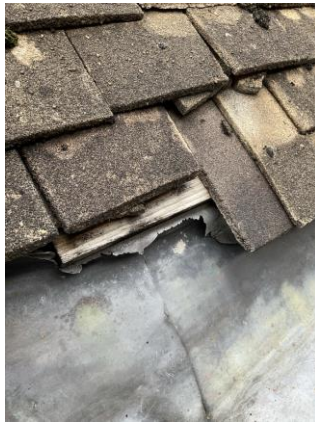
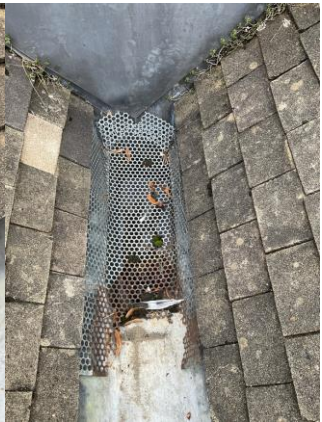
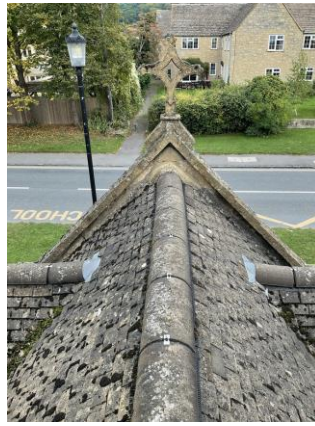
Condition Item 0

Floor / Elevation	Pitched Roof
Location	Original 1861 school building.
Location Ref	Halls
Element/Sub Element	4
Element ID	Roofs
Condition Grade (A-D)	B
Priority (1-4)	4
Description	Timber framed truss rafter 'cut' roof with concrete plane tiles and breathable under sarking. Stone parapets to gables.
Defect	The roof is showing some minor defects with a few broken tiles and poor detailing around leadwork around the hopper outlet to the rear of the roof valley.
Consequence of Inaction / Remedy	The roof will continue to deteriorate with a risk of water ingress. The tiles and lead work should be repaired soon to preserve the roof and structural fabric.
Target Year	05/11/2025
Residual Life	10+
Approx. Quantity	1
Unit	Estimated
Rate	525
Cyclical	
Period	
Period Type	
Estimated Cost	525
Risk Rating	Green

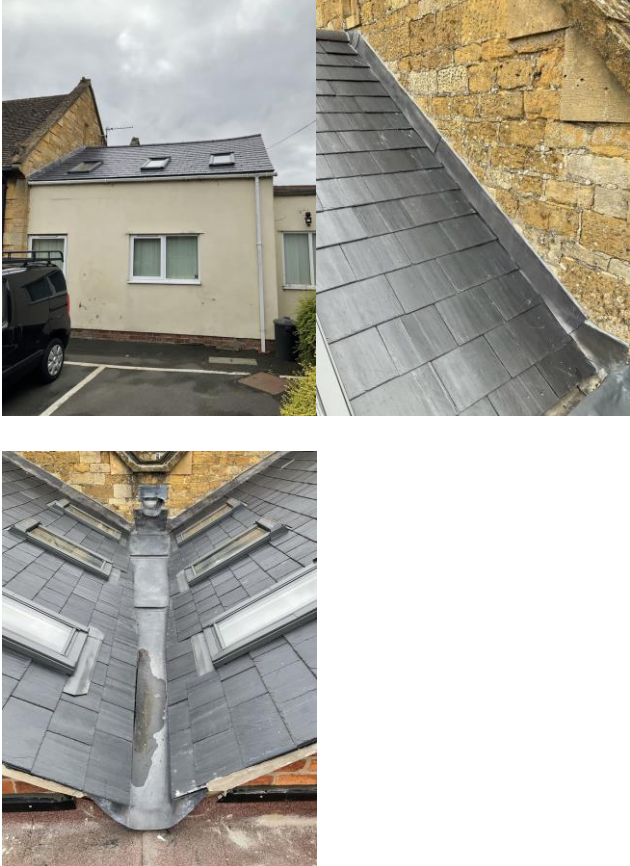
Condition Item (1)

<p>Floor / Elevation</p>	<p>Roof</p>
<p>Location</p>	<p>IT Room and stage</p>
<p>Location Ref</p>	
<p>Element/Sub Element</p>	<p>4</p>
<p>Element ID</p>	<p>Roofs</p>
<p>Condition Grade (A-D)</p>	<p>A</p>
<p>Priority (1-4)</p>	<p>4</p>
<p>Description</p>	<p>Pitched roof with man-made slate tile covering and roof lights.</p>
<p>Defect</p>	<p>The roof was recovered in 2020/21. and covered with a 12 months defects period.</p>
<p>Consequence of Inaction / Remedy</p>	<p>N/A</p>
<p>Target Year</p>	
<p>Residual Life</p>	<p>10+</p>
<p>Approx. Quantity</p>	<p>1</p>

Unit	
Rate	
Cyclical	
Period	
Period Type	
Estimated Cost	0
Risk Rating	Blue

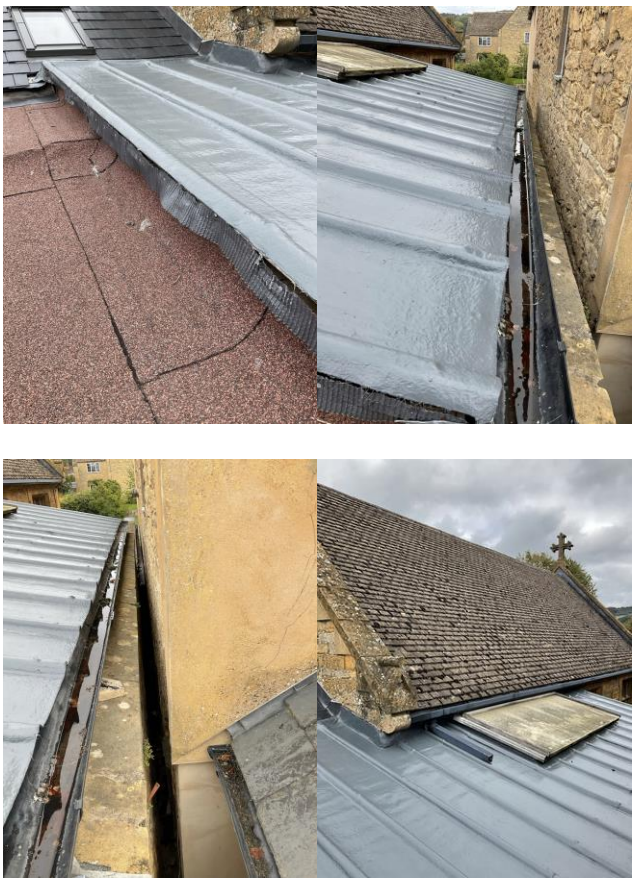
Condition Item (2)

Floor / Elevation	Roof
Location	Above Hall Kitchen / stage store area
Location Ref	
Element/Sub Element	4
Element ID	Roofs

Condition Grade (A-D)	C
Priority (1-4)	3
Description	Original roof covered with a liquid fiber reinforced temporary covering.
Defect	The original roof covering below may be asbestos cement sheet and the school should proceed with caution when undertaking repairs. The verge detail is poorly finished and in need of repairs and alterations to ensure water does not penetrate the building.
Consequence of Inaction / Remedy	Undertake repairs to prevent water penetration at verge. Proceed with caution as there is a risk of asbestos.
Target Year	01/11/2024
Residual Life	5
Approx. Quantity	1
Unit	Estimated
Rate	450
Cyclical	
Period	
Period Type	
Estimated Cost	450
Risk Rating	Amber

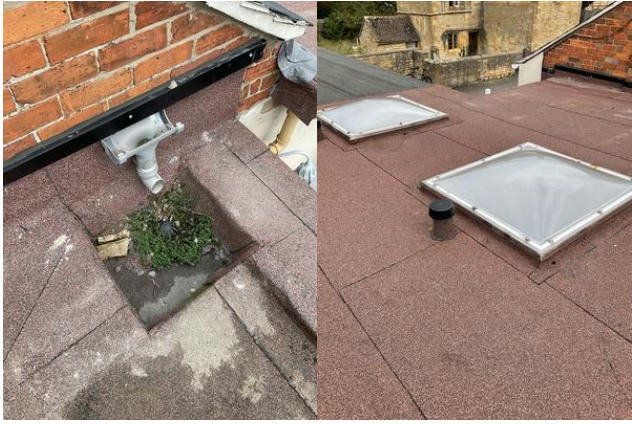
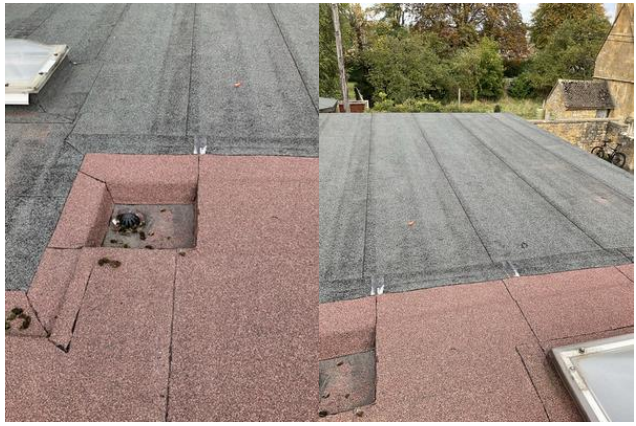
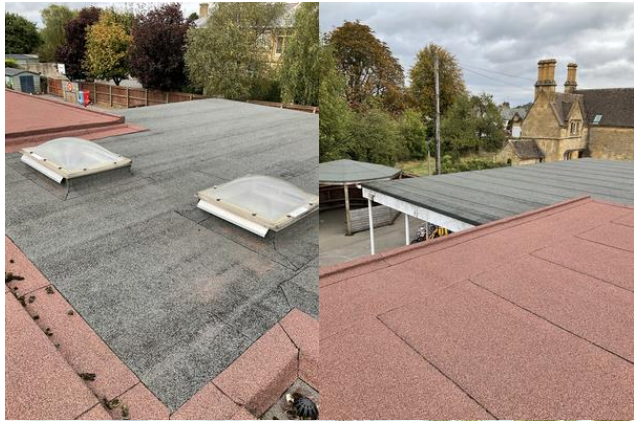
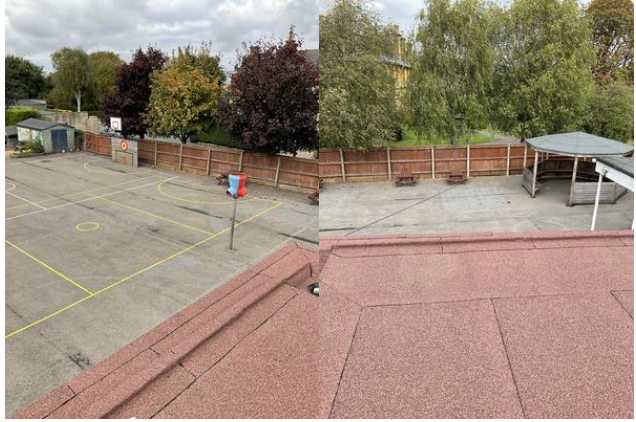
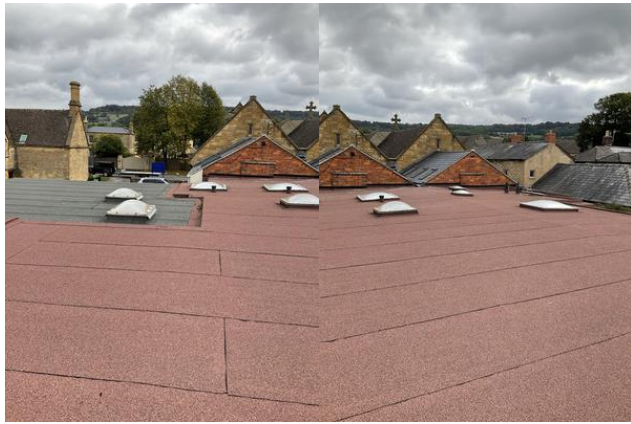
Condition Item (3)

Floor / Elevation	Roofs
Location	Rear classroom and office areas
Location Ref	
Element/Sub Element	4
Element ID	Roofs
Condition Grade (A-D)	C
Priority (1-4)	3
Description	Flat roofs with a bitumen mineral felt covering.
Defect	The roofs lights are not positioned high enough. Min 150mm vertically off the roof deck.
Consequence of Inaction / Remedy	This presents a risk of water ingress. The roof lights should be removed with the kerb raised and dressed with felt and roof lights replaced or refitted as necessary. Allowance required to make good internally.
Target Year	
Residual Life	
Approx. Quantity	1
Unit	Estimated
Rate	3375
Cyclical	
Period	
Period Type	
Estimated Cost	3375
Risk Rating	Amber

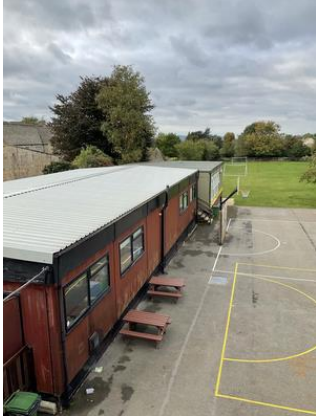
Condition Item (4)

Floor / Elevation	Roof
Location	Temp classroom block 1
Location Ref	
Element/Sub Element	4
Element ID	Roofs
Condition Grade (A-D)	B
Priority (1-4)	4
Description	Coated profiled sheet cladding.
Defect	None
Consequence of Inaction / Remedy	Maintain in the normal way.
Target Year	02/11/2026
Residual Life	6-9
Approx. Quantity	
Unit	
Rate	
Cyclical	
Period	
Period Type	
Estimated Cost	0
Risk Rating	Blue

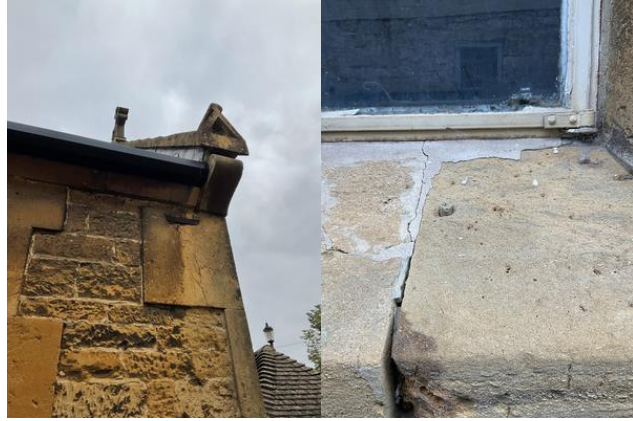
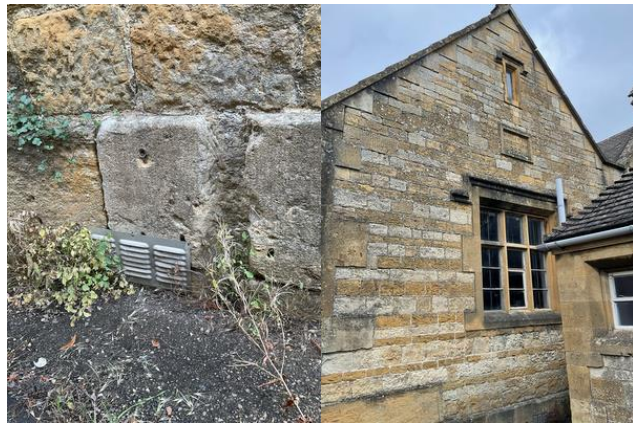
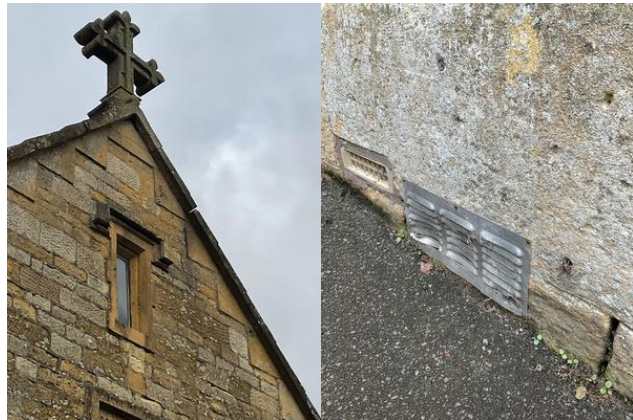
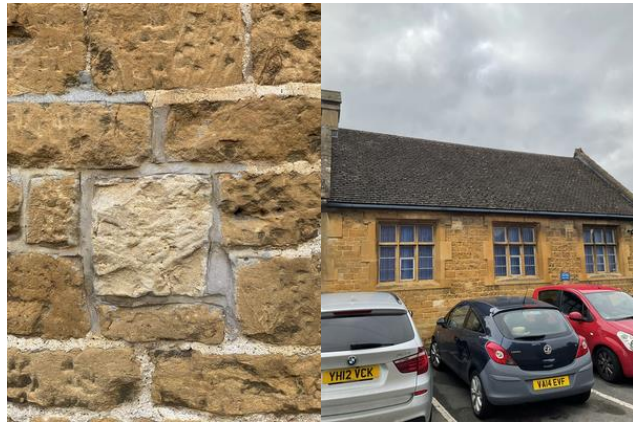
Condition Item (6)

Floor / Elevation	Original 1861 school building.
Location	
Location Ref	
Element/Sub Element	6
Element ID	External Walls
Condition Grade (A-D)	C
Priority (1-4)	3
Description	Solid stone walls with lime mortar bed joints and pointing.
Defect	Isolated areas require repointing. Cement mortar should be carefully removed and replaced with lime mortar. Defective sub floor ventilation.
Consequence of Inaction / Remedy	The bed joints in isolated areas should be raked out and repointed with lime mortar. Cementitious mortars should not be used and removed as this will lead to damage to stone. The external walls are vulnerable to dampness from poorly maintained rainwater goods. There is evidence the gutters are ineffective.
Target Year	01/11/2024
Residual Life	3
Approx. Quantity	1
Unit	Estimated
Rate	16575
Cyclical	
Period	
Period Type

Estimated Cost	16575
Risk Rating	Green

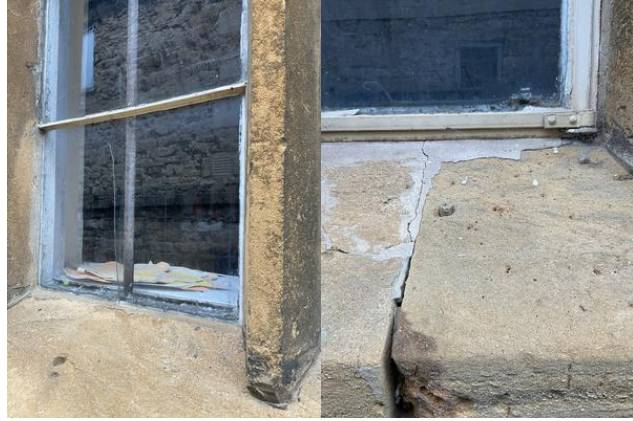
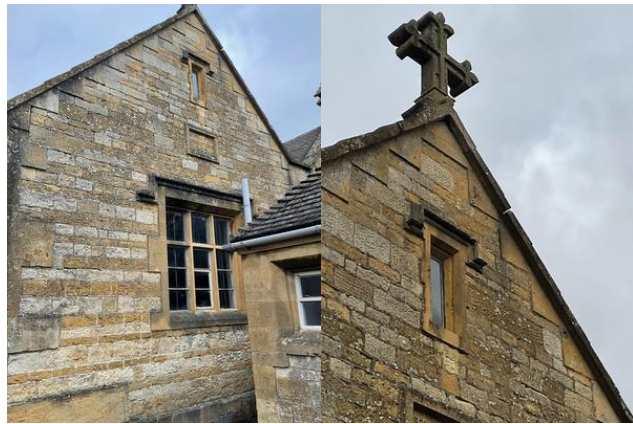
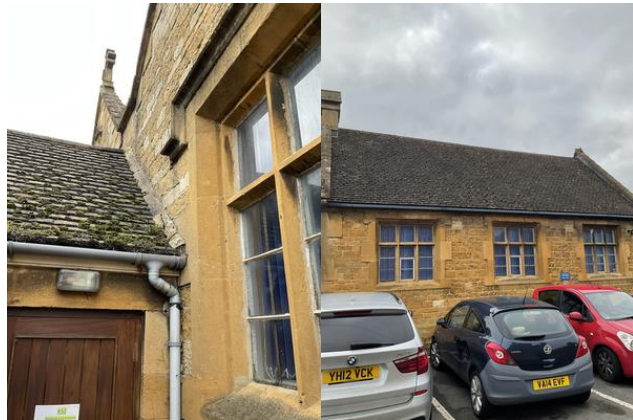
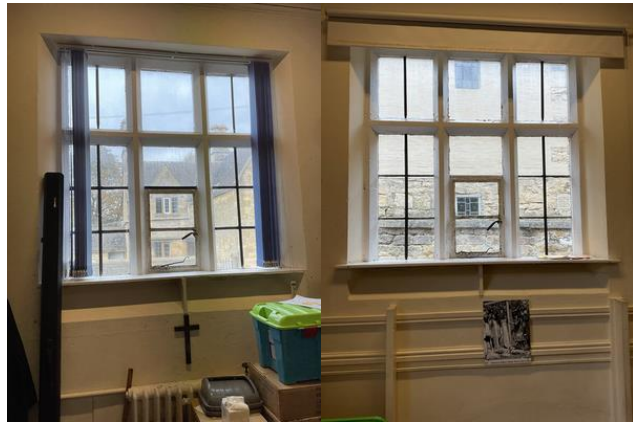
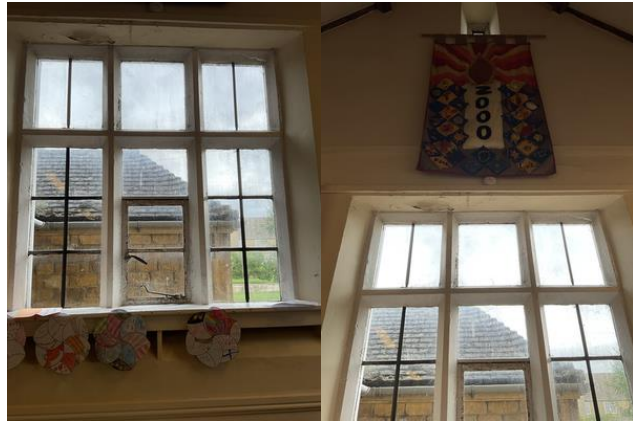
Condition Item (8)

Item Ref (Please refer to risk grading on page 10)	Item Description	Estimated Cost
8	<p>Original wrought iron lights with single glazing. These windows have poor thermal performance and are draughty. Some glazing is cracked. Special care should be taken with repairs to these glazed units to preserve the special characteristics of the original building. If replacement is planned, you should consult with the local planning authority. It is strongly recommended new internal horizontal sliding double glazed secondary units are installed to improve the thermal comfort.</p>	£23150
9	<p>Solid external walls affected by dampness and mould. Walls have black spot mould (<i>Stachybotrys chartarum</i>). caused though poor ventilation and control of moist internal air and poorly insulated walls. This mould is known to have a negative impact on persons with breathing health issues. The ventilation should be improved, and walls cleaned and better insulated.</p>	£12500

Original 1861 building

These windows have poor thermal performance and are draughty. Some glazing is cracked.

Special care should be taken with repairs to these glazed units to preserve the special characteristics of the original building. If replacement is planned, you should consult with the local planning authority. It is strongly recommended new internal horizontal sliding double glazed secondary units are installed to improve the thermal comfort.

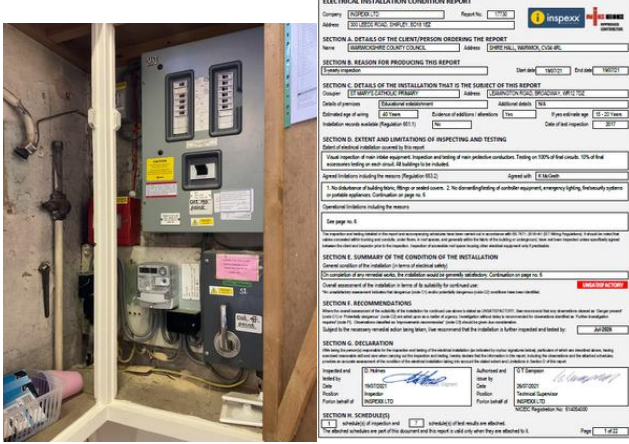
Condition Item (10)

10	<p>Electrical mains and intake cupboard. The client has reported issues on site with a lack of capacity of the mains electricity. The cupboard is easily accessible to children and the housing does not provide adequate fire protection. The most up to date 5-year fixed wiring report details C1, C2 and F1 items with recommendations for improvements with potentially dangerous conditions. There is a danger to children because of poor protection of the electrical intake and spread of fire should the already overloaded unit overheat and combust. Plan to upgrade the electrical supply, distribution, and housing.</p>	£27578
13	<p>Original heating distribution and heat emitters. Pipework and radiators more than 60 years old and showing signs of internal corrosion. Leaks and heating shutdowns are likely. Plan to overhaul and replace the heating distribution pipework.</p>	£42294

52.507443, -1.710490</p>
<p>Floor / Elevation</p>	<p>GF</p>
<p>Location</p>	<p>Main building</p>
<p>Location Ref</p>	
<p>Element/Sub Element</p>	<p>24</p>
<p>Element ID</p>	<p>Electrical Systems and Equipment</p>
<p>Condition Grade (A-D)</p>	<p>D</p>
<p>Priority (1-4)</p>	<p>2</p>
<p>Description</p>	<p>Electrical mains and intake cupboard.</p>
<p>Defect</p>	<p>The client has reported issues on site with a lack of capacity of the mains electricity. The cupboard is easily accessible to children and the housing does not provide adequate fire protection. The most up to date 5-year fixed wiring report details C1, C2 and F1 items with recommendations for improvements with potentially dangerous conditions.</p>
<p>Consequence of Inaction / Remedy</p>	<p>There is a danger to children because of poor protection of the electrical intake and spread of fire should the already overloaded unit overheat and combust. Plan to upgrade the electrical supply, distribution, and housing.</p>

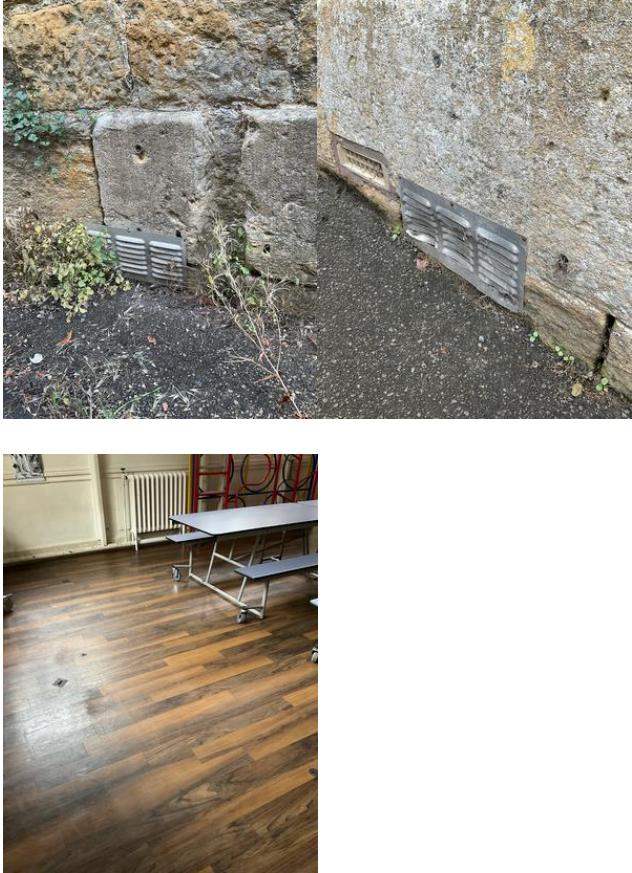
Condition Item (11)

11	Suspended timber floors. Floors are covered with impervious coverings. The floors are at risk from dampness and wood rot / insect infestations. Plan to improve sub floor insulation and ventilation. Only breathable coverings should be used to prevent the floor from moisture damage.	£32150
12	Original internal doors. Some doors may have asbestos boards affixed to them. Original doors and internal screens and glazing is likely to fall short of modern standards for fire doors and protected escape routes. Rapid fire spread and compromised fire escape routes. Plan to replace doors and alter screens to bring the fire compartmentation and protection of escape routes in line with modern standards.	£23400
15	Original ceiling boards are likely to be asbestos. Plan to remove if building works dictate the need.	£5520
16	Asbestos soffit and fascia boards. Flaking paint can contaminate areas where children may frequent. Damaged fascia boards and canopy fixed through asbestos sheets. Potential for contamination and release of asbestos fibres. Plan to remove damaged boards and replace with alternative.	£15650

Floor / Elevation	Original 1861 building.
Location	
Location Ref	
Element/Sub Element	3
Element ID	Floors
Condition Grade (A-D)	C

Priority (1-4)	3
Description	Suspended timber floors.
Defect	Floors are covered with impervious coverings.
Consequence of Inaction / Remedy	The floors are at risk from dampness and wood rot / insect infestations. Plan to improve sub floor insulation and ventilation. Only breathable coverings should be used to prevent the floor from moisture damage.
Target Year	01/11/2024
Residual Life	5
Approx. Quantity	1
Unit	Estimated
Rate	32150
Cyclical	
Period	
Period Type	
Estimated Cost	32150
Risk Rating	Green

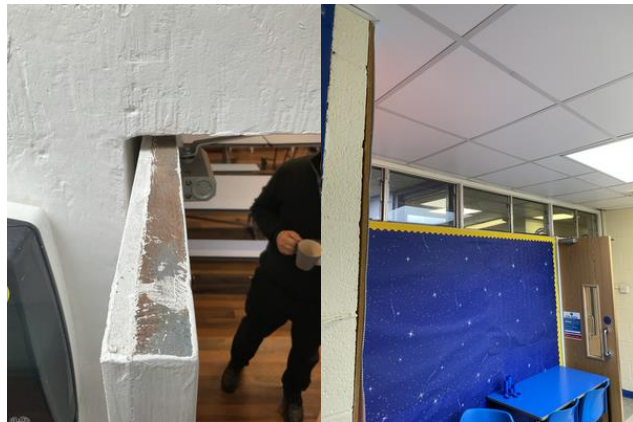
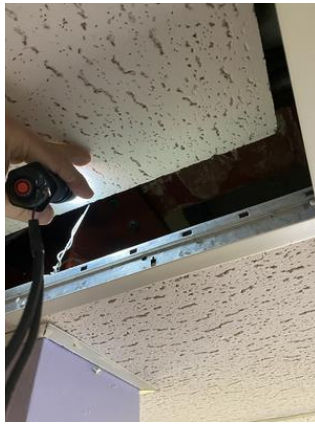
Condition Item (12)

Floor / Elevation	GF
Location	
Location Ref	
Element/Sub Element	12
Element ID	Internal Doors
Condition Grade (A-D)	C
Priority (1-4)	3
Description	Original internal doors.
Defect	Some doors may have asbestos boards affixed to them. Original doors and internal screens and glazing is likely to fall short of modern standards for fire doors and protected escape routes.
Consequence of Inaction / Remedy	Rapid fire spread and compromised fire escape routes. Plan to replace doors and alter screens to bring the fire compartmentation and protection of escape routes in line with modern standards.
Target Year	01/11/2024
Residual Life	5
Approx. Quantity	1
Unit	Estimated
Rate	23400
Cyclical	
Period	
Period Type	
Estimated Cost	23400
Risk Rating	Amber

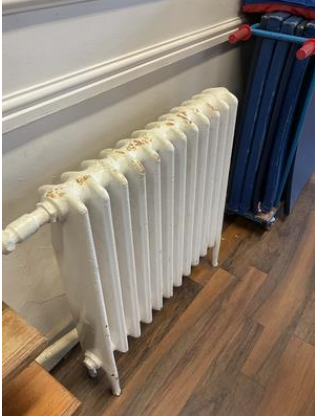
Condition Item (13)

Floor / Elevation	Gf
Location	Original building and 1970's areas.
Location Ref	
Element/Sub Element	35
Element ID	Heating Distribution
Condition Grade (A-D)	D
Priority (1-4)	2
Description	Original heating distribution and heat emitters.
Defect	Pipework and radiators more than 60 years old and showing signs of internal corrosion.
Consequence of Inaction / Remedy	Leaks and heating shutdowns are likely. Plan to overhaul and replace the heating distribution pipework.
Target Year	01/11/2024
Residual Life	5
Approx. Quantity	1
Unit	Estimated
Rate	42294
Cyclical	
Period	
Period Type	
Estimated Cost	42294

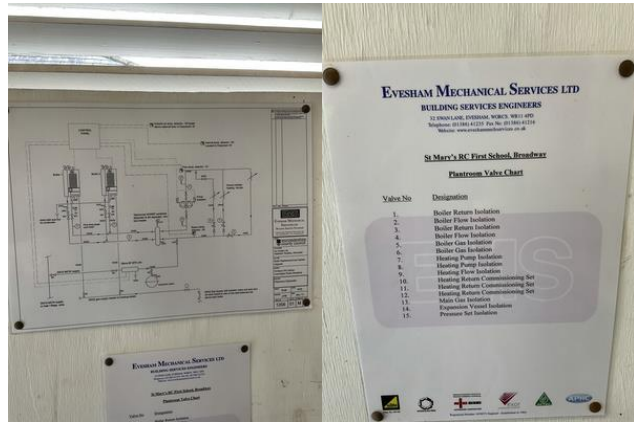
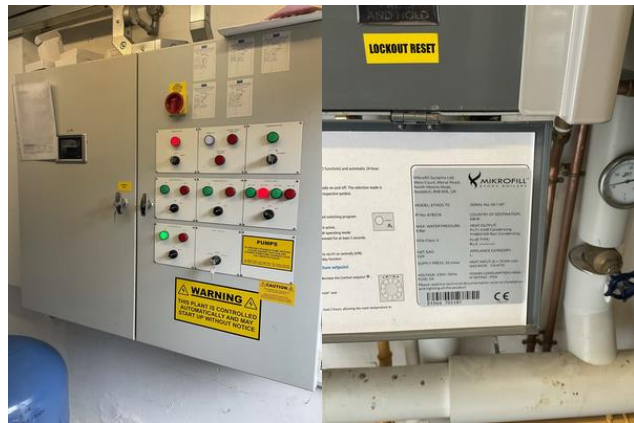
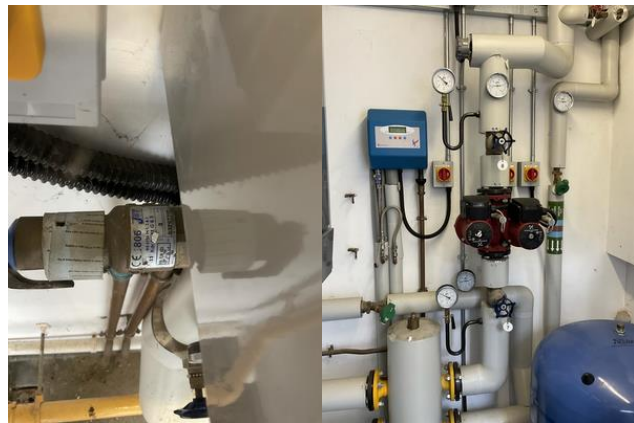
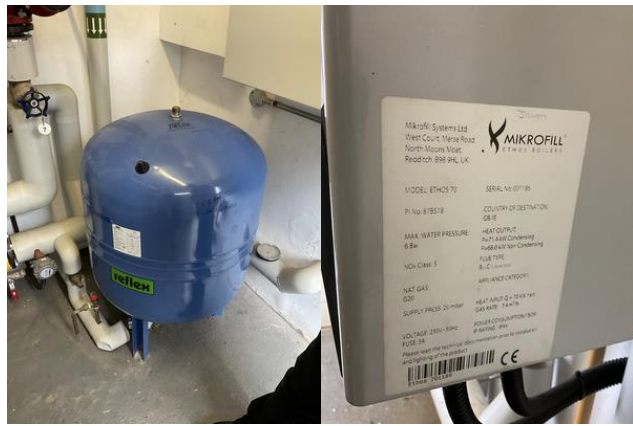
Condition Item (14)

Floor / Elevation	GF
Location	Boiler room
Location Ref	
Element/Sub Element	23
Element ID	Gas Services
Condition Grade (A-D)	B
Priority (1-4)	4
Description	Exiting Mikrofill Ethos boilers replaced c.2011.
Defect	None
Consequence of Inaction / Remedy	Maintain in the normal way.
Target Year	
Residual Life	10+
Approx. Quantity	
Unit	
Rate	
Cyclical	
Period	
Period Type	
Estimated Cost	0
Risk Rating	Blue

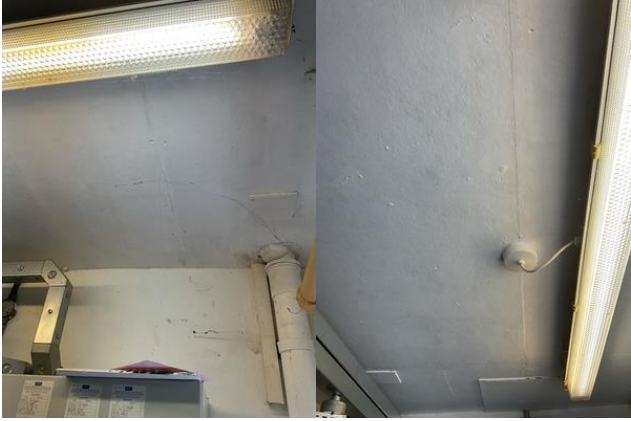
Condition Item (15)

Floor / Elevation	Boiler Room
Location	Ceiling
Location Ref	
Element/Sub Element	11
Element ID	Ceilings
Condition Grade (A-D)	C
Priority (1-4)	3
Description	Original ceiling boards are likely to asbestos.
Defect	None
Consequence of Inaction / Remedy	Plan to remove if building works dictate the need.
Target Year	01/11/2026
Residual Life	
Approx. Quantity	1
Unit	
Rate	5520
Cyclical	
Period	
Period Type	
Estimated Cost	5520
Risk Rating	Green

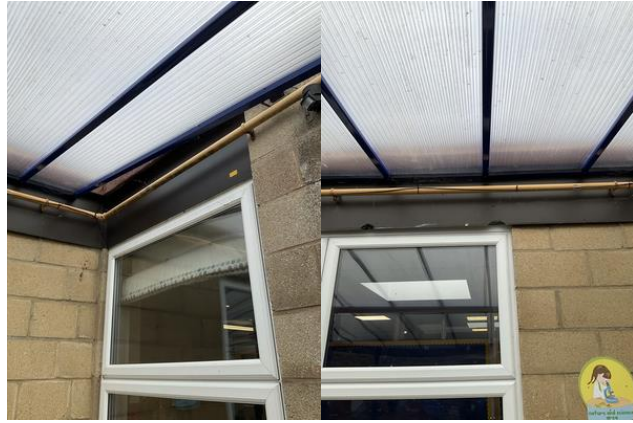
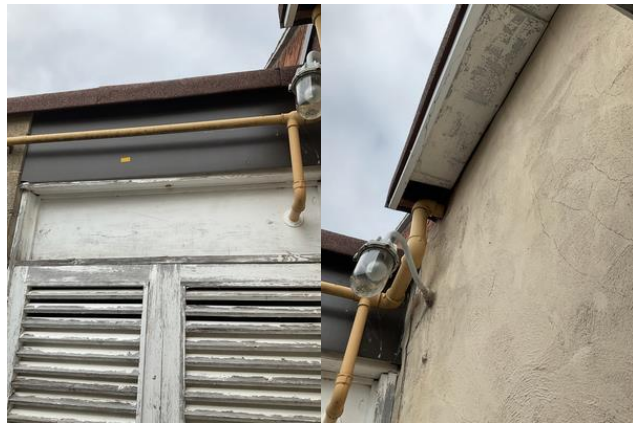
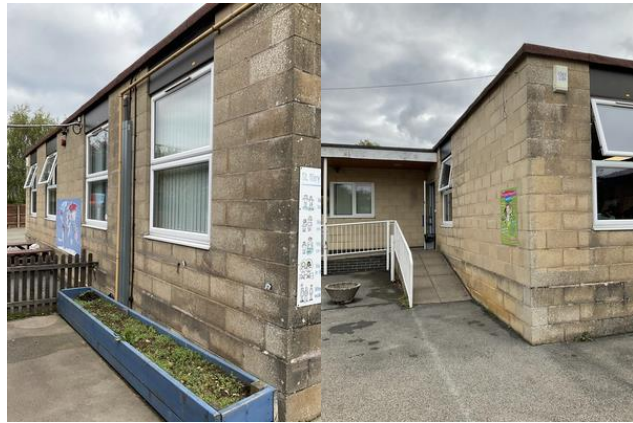
Condition Item (16)

External Areas

Condition Grade (A-D)	C
Priority (1-4)	3
Description	Asbestos soffit and fascia boards.
Defect	Flacking paint can contaminate areas where children may frequent. Damaged fascia boards and canopy fixed through asbestos sheets.
Consequence of Inaction / Remedy	Potential for contamination and release of asbestos fibers. Plan to remove damaged boards and replace with alternative.
Target Year	07/11/2024
Residual Life	3
Approx. Quantity	1
Unit	Estimated
Rate	15650
Cyclical	
Period	
Period Type	
Estimated Cost	15650
Risk Rating	Amber

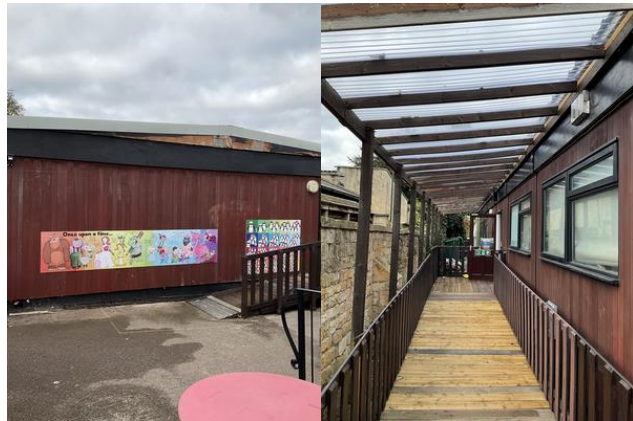
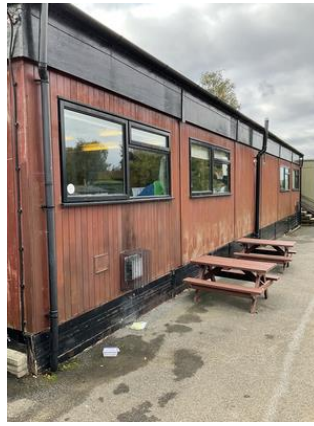
Condition Item (17)

17	<p>1970's temporary classroom block.</p> <p>Temporary buildings are by design lacking in insulation and manufactured with a limited life expectancy of 10 - 20 years. This building has now surpassed its design life and falls short of modern standards for educational buildings. Users will be exposed to extremes of temperature and the buildings are expensive to heat and cool.</p> <p>Ultimately the building does not provide adequate accommodation and is likely to have a detrimental impact on attainment at the school.</p> <p>Plan to replace the building with a permanent structure soon.</p>	£49799
18	<p>1970's temporary classroom block.</p> <p>Temporary buildings are by design lacking in insulation and manufactured with a limited life expectancy of 10 - 20 years. This building has now surpassed its design life and falls short of modern standards for educational buildings. Users will be exposed to extremes of temperature and the buildings are expensive to heat and cool.</p> <p>Parts of the structure are rotten and moisture ingress will accelerate the deterioration of the building.</p> <p>Plan to replace soon.</p> <p>No cost attributed to this as it has been recorded above for the replacement of both units.</p>

Floor / Elevation	GF
Location	Temporary class 1
Location Ref	
Element/Sub Element	2
Element ID	Frame
Condition Grade (A-D)	D
Priority (1-4)	2
Description	1970's temporary classroom block.
Defect	Temporary buildings are by design lacking in insulation and manufactured with a limited life expectancy of 10 - 20 years. This building has now surpassed its design life and falls short of modern standards for educational buildings. Users will be exposed to extremes of temperature and the buildings are expensive to heat and cool.
Consequence of Inaction / Remedy	Ultimately the building does not provide adequate accommodation and is likely to have a detrimental impact on attainment at the school. Plan to replace the building with a permanent structure soon.
Target Year	01/11/2023
Residual Life	2
Approx. Quantity	1
Unit	Estimated
Rate	497999
Cyclical	
Period

Period Type	
Estimated Cost	497999
Risk Rating	Amber

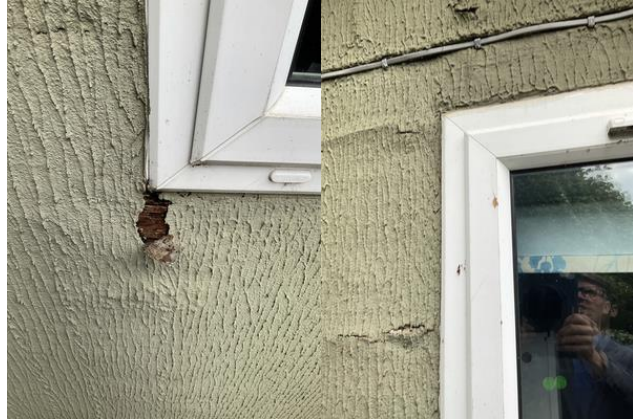
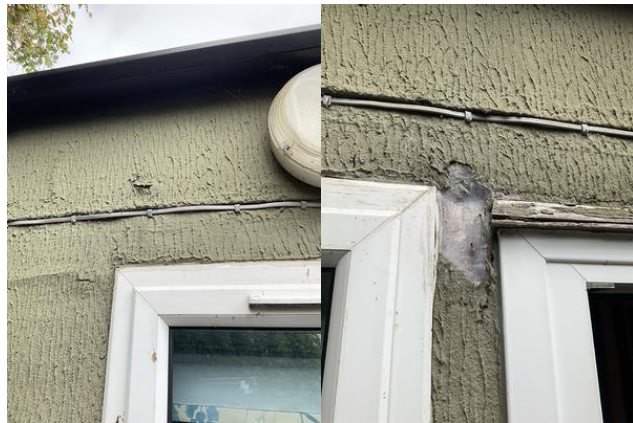
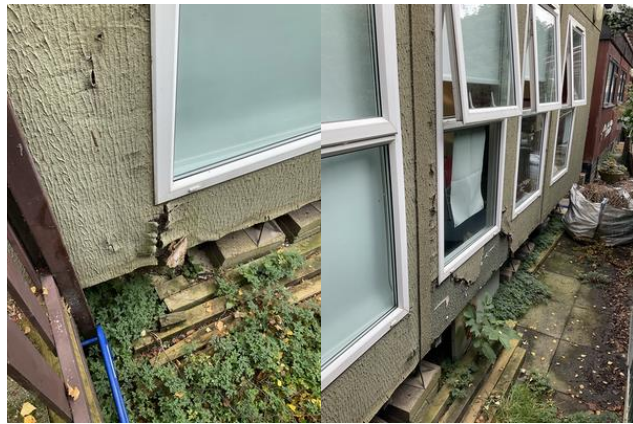
Condition Item (18)

Location	Temporary Building 2
Location Ref	
Element/Sub Element	2
Element ID	Frame
Condition Grade (A-D)	D
Priority (1-4)	2
Description	1970's temporary classroom block.
Defect	Temporary buildings are by design lacking in insulation and manufactured with a limited life expectancy of 10 - 20 years. This building has now surpassed its design life and falls short of modern standards for educational buildings. Users will be exposed to extremes of temperature and the buildings are expensive to heat and cool.
Consequence of Inaction / Remedy	Parts of the structure are rotten and moisture ingress will accelerate the deterioration of the building. Plan to replace soon. No cost attributed to this as it has been recorded above for the replacement of both units.
Target Year	02/11/2023
Residual Life	2
Approx. Quantity	
Unit	
Rate	
Cyclical	
Period	
Period Type	
Estimated Cost	0
Risk Rating	Amber

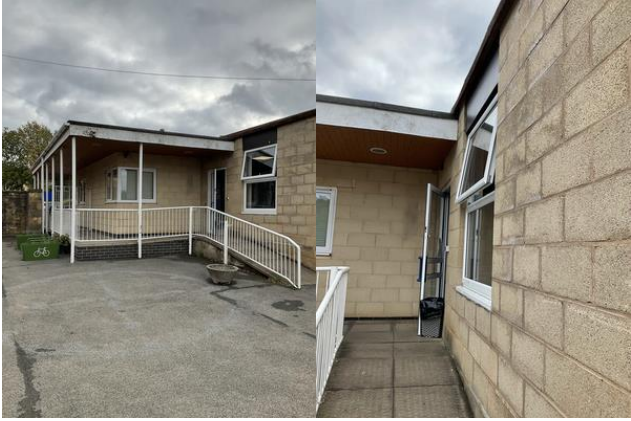
Condition Item (19)

19	External ramp. The ramp is too steep for use as a DDA compliant access. Difficulties for staff and children with impaired mobility to use. Plan to alter or replace with a compliant ramp.	£15988
21	Stone boundary wall. The wall is out of plumb and leaning slightly. The wall may continue to move over time. This should be monitored annually for any changes and repaired if deemed necessary. Ownership of the wall should be established to attribute any checks and costs to the owner. Cost for surveys and reports.	£494
23	Timber access ramps. The ramps are showing signs of deterioration and levels are non-compliant with statutory guidelines. Risk of accidents and ongoing repair costs.	£19958
30	Electrical distribution. Existing distribution at full capacity and non-compliant with current standards. Power outages likely. Plan to replace and re wire circuits.	£6000
31	Surface mounted fluorescent lighting. Lighting is aged and inadequate to provide optimum levels of lighting. Parts now obsolete and fittings are not energy efficient.	£24985

Floor / Elevation	External Ramps
Location	Main building.
Location Ref	
Element/Sub Element	29
Element ID	Access
Condition Grade (A-D)	C
Priority (1-4)	3
Description	External ramp.
Defect	The ramp is too steep for use as a DDA compliant access.
Consequence of Inaction / Remedy	Difficulties for staff and children with impaired mobility to use. Plan to alter or replace with a compliant ramp.
Target Year	08/11/2024
Residual Life	
Approx. Quantity	1
Unit	Estimated
Rate	15988
Cyclical	
Period	
Period Type	
Estimated Cost	15988
Risk Rating	Green

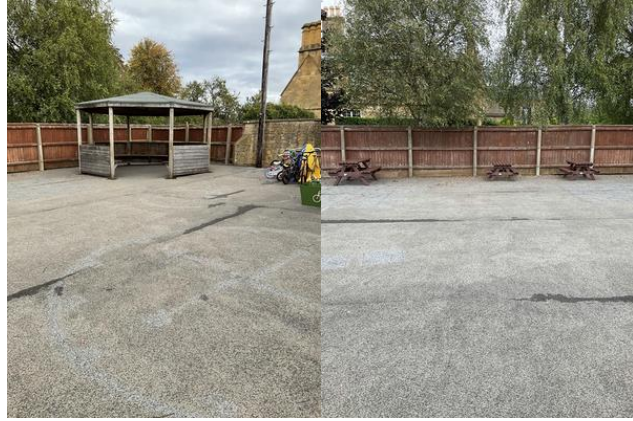
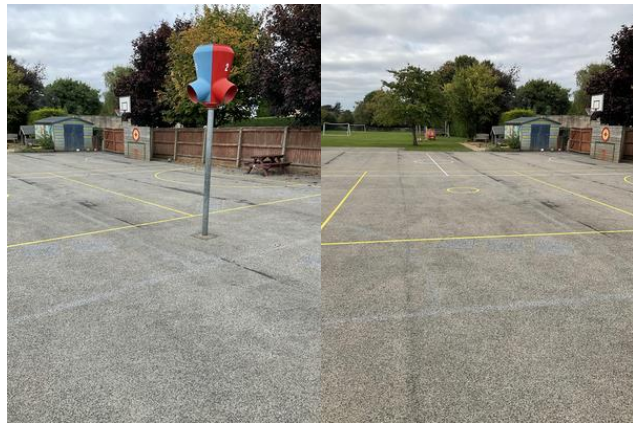
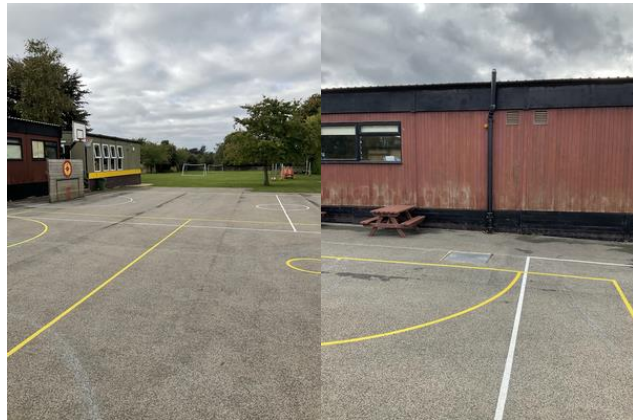
Condition Item (20)

Playground

Condition Grade (A-D)	B
Priority (1-4)	4
Description	Hot rolled asphalt surfacing.
Defect	None
Consequence of Inaction / Remedy	Maintain in the normal way.
Target Year	02/11/2026
Residual Life	6-9
Approx. Quantity	
Unit	
Rate	
Cyclical	
Period	
Period Type	
Estimated Cost	0
Risk Rating	Blue

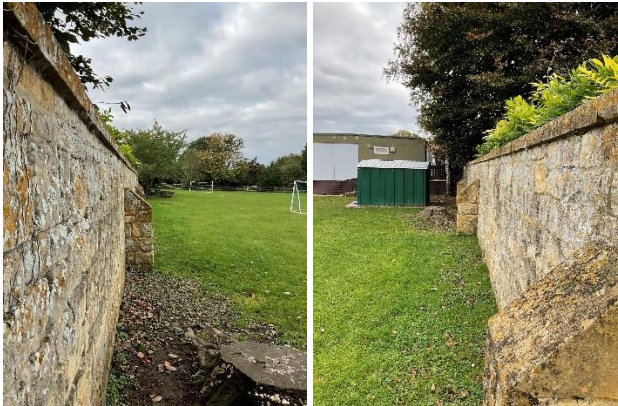
Condition Item (21)

Floor / Elevation	Boundary wall
Location	Rear of property.
Location Ref	
Element/Sub Element	6
Element ID	External Walls
Condition Grade (A-D)	C

Priority (1-4)	3
Description	Stone boundary wall.
Defect	The wall is out of plumb and leaning slightly.
Consequence of Inaction / Remedy	The wall may continue to move over time. This should be monitored annually for any changes and repaired if deemed necessary. Ownership of the wall should be established to attribute any checks and costs to the owner. Cost for surveys and reports.
Target Year	01/11/2024
Residual Life	
Approx. Quantity	1
Unit	Estimated
Rate	494
Cyclical	
Period	
Period Type	
Estimated Cost	494
Risk Rating	Amber

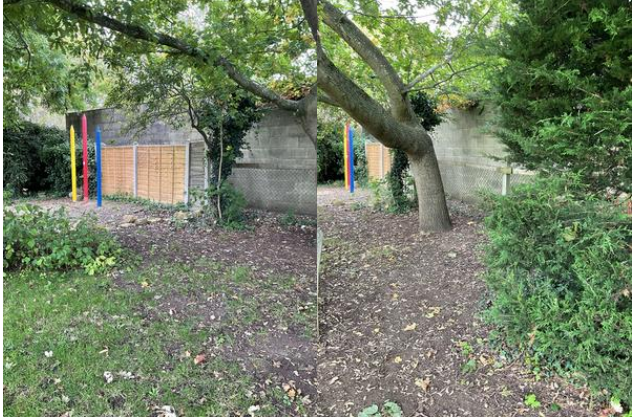
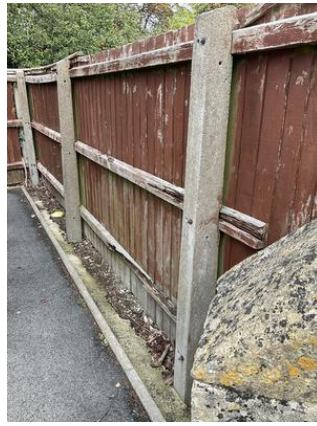
Condition Item (22)

22	<p>Wire mesh and timber fencing.</p> <p>Low fencing and rotten timber.</p> <p>The low fence is a safeguarding issue, and the rotting timber fence may become insecure. You should plan to replace and repair the section of fencing presenting a safeguarding risk.</p>	£1800
25	<p>Existing toilet cubicles are unsuitable for the age group.</p> <p>The cubicles are too high making monitoring and safeguarding difficult.</p> <p>Plan to replace if the mobile classroom block is retained.</p>	£30000
27	<p>Partition walls between rooms and corridors.</p> <p>Gaps in ceiling voids and service protrusions through walls.</p> <p>Compartmentation and protection from the spread of fire and smoke is compromised. A furthermore in-depth targeted survey should be undertaken to establish the gaps and risks which should be used to identify and repair and upgrade the walls to provide protection.</p> <p>Cost for further intrusive survey and report.</p>	£1598

Floor / Elevation	Rear grounds
Location	Boundary
Location Ref	
Element/Sub Element	33
Element ID	Grounds
Condition Grade (A-D)	D
Priority (1-4)	2
Description	Wire mesh and timber fencing.
Defect	Low fencing and rotten timber.
Consequence of Inaction / Remedy	The low fence is a safeguarding issue, and the rotting timber fence may become insecure. You should plan to replace and repair the section of fencing presenting a safeguarding risk.
Target Year	01/11/2023
Residual Life	2
Approx. Quantity	30
Unit	Estimated
Rate	60
Cyclical	
Period	
Period Type	
Estimated Cost	1800
Risk Rating	Amber

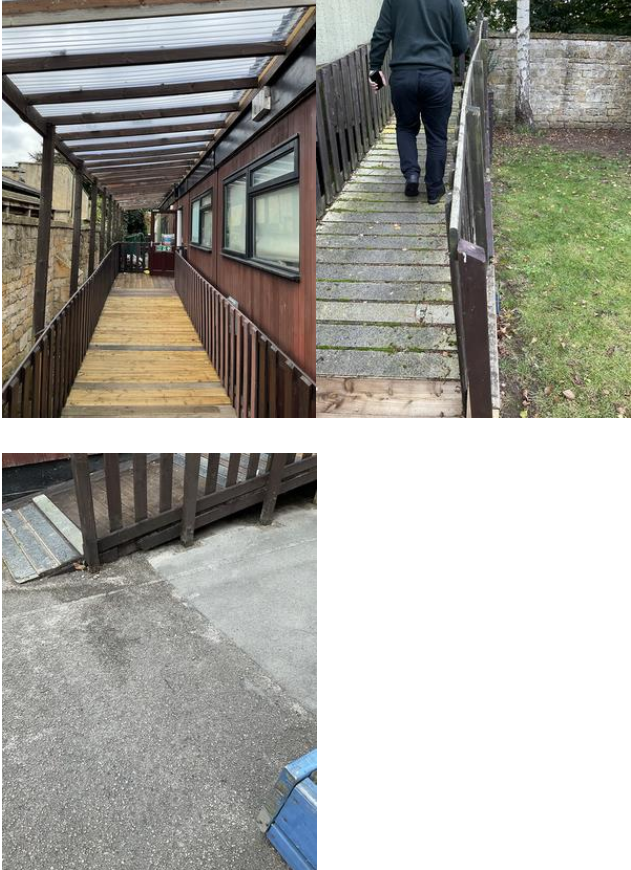
Condition Item (23)

<p>Floor / Elevation</p>	<p>Temporary Classrooms</p>
<p>Location</p>	
<p>Location Ref</p>	
<p>Element/Sub Element</p>	<p>5</p>
<p>Element ID</p>	<p>Stairs / Ramps</p>
<p>Condition Grade (A-D)</p>	<p>C</p>
<p>Priority (1-4)</p>	<p>3</p>
<p>Description</p>	<p>Timber access ramps.</p>
<p>Defect</p>	<p>The ramps are showing signs of deterioration and levels are non-compliant with statutory guidelines.</p>
<p>Consequence of Inaction / Remedy</p>	<p>Risk of accidents and ongoing repair costs.</p>
<p>Target Year</p>	<p>01/11/2023</p>
<p>Residual Life</p>	<p>3</p>
<p>Approx. Quantity</p>	<p>1</p>

Unit	Estimated
Rate	19958
Cyclical	
Period	
Period Type	
Estimated Cost	19958
Risk Rating	Amber

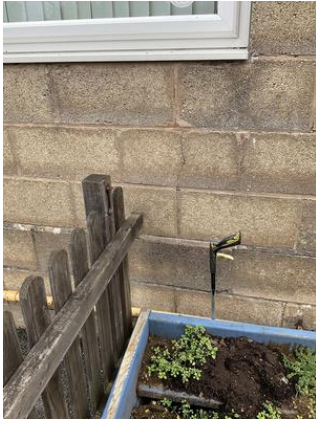
Condition Item (24)

Floor / Elevation	Main building
Location	
Location Ref	
Element/Sub Element	6
Element ID	External Walls
Condition Grade (A-D)	B
Priority (1-4)	4
Description	External blockwork walls.
Defect	Minor patched or repointing required. Some minor cracking to walls.
Consequence of Inaction / Remedy	Continual deterioration is likely. The cracking is due to thermal changes and likely non progressive movement.
Target Year	02/11/2026
Residual Life	6-9

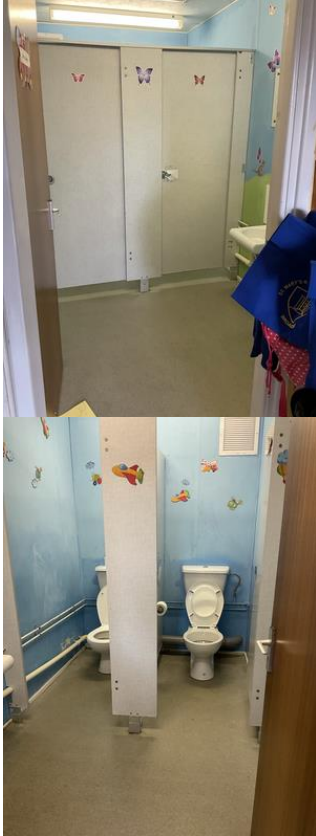
Condition Item (25)

Floor / Elevation	Temporary class block
Location	Toilets.
Location Ref	
Element/Sub Element	13
Element ID	Toilets and changing

Condition Grade (A-D)	D
Priority (1-4)	2
Description	Existing toilet cubicles are unsuitable for the age group.
Defect	The cubicles are too high making monitoring and safeguarding difficult.
Consequence of Inaction / Remedy	Plan to replace if the mobile classroom if the block is not replaced.
Target Year	02/11/2023
Residual Life	2
Approx. Quantity	2
Unit	Estimated
Rate	15000
Cyclical	
Period	
Period Type	
Estimated Cost	30000
Risk Rating	Amber

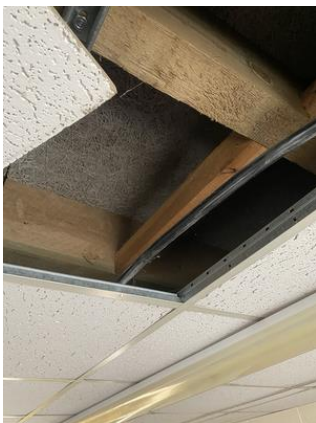
Condition Item (26)

Floor / Elevation	Roof
Location	1970s main block
Location Ref	
Element/Sub Element	4

Element ID	Roofs
Condition Grade (A-D)	B
Priority (1-4)	4
Description	Woodwool roof deck.
Defect	None. This material can become unstable during the stripping of defunct felt coverings.
Consequence of Inaction / Remedy	Care should be taken when felt roofs are replaced.
Target Year	06/11/2025
Residual Life	
Approx. Quantity	
Unit	
Rate	
Cyclical	
Period	
Period Type	
Estimated Cost	0
Risk Rating	Blue

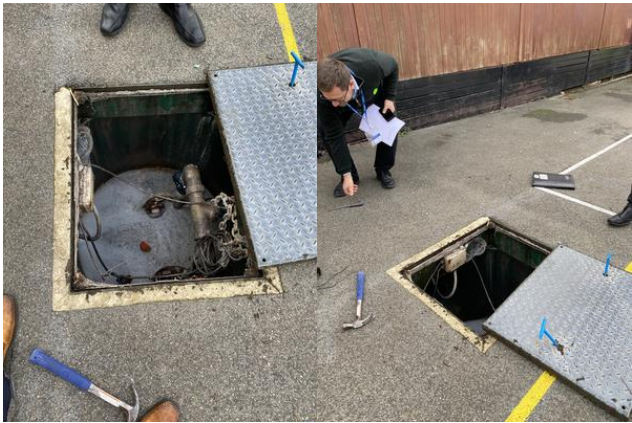
Condition Item (28)

Floor / Elevation	Grounds
Location	Adjacent temporary classrooms.
Location Ref	
Element/Sub Element	15
Element ID	Drainage
Condition Grade (A-D)	B

Priority (1-4)	4
Description	Foul drainage serving the temporary classrooms.
Defect	None. Maintain In the normal way.
Consequence of Inaction / Remedy	The school where unaware of the pump. Annual checks and servicing should be undertaken to keep the pump in good condition and fully operational.
Target Year	05/11/2026
Residual Life	5
Approx. Quantity	
Unit	
Rate	
Cyclical	
Period	
Period Type	
Estimated Cost	0
Risk Rating	Blue

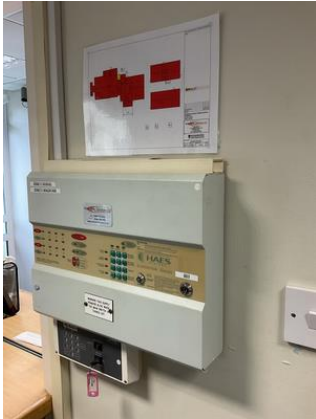
Condition Item (29)

29	<p>The school fire alarm system. The system is lacking in automatic fire detection. You should plan to replace or upgrade the system for automatic fire detection.</p>	£62500
----	--	--------

52.507443, -1.710490
Floor / Elevation	Gf Entire school
Location	
Location Ref	
Element/Sub Element	27

Element ID	Fire Detection
Condition Grade (A-D)	D
Priority (1-4)	2
Description	The school fire alarm system.
Defect	The system is lacking in automatic fire detection.
Consequence of Inaction / Remedy	You should plan to replace or upgrade the system for automatic fire detection.
Target Year	02/11/2023
Residual Life	2
Approx. Quantity	1
Unit	Estimated
Rate	62500
Cyclical	
Period	
Period Type	
Estimated Cost	62500
Risk Rating	Amber

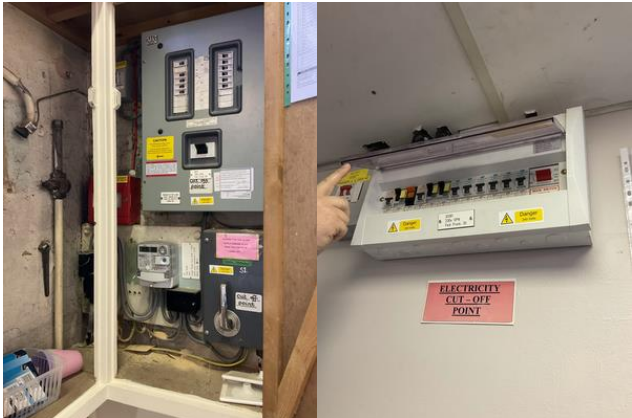
Condition Item (30)

52.507443, -1.710490
Floor / Elevation	GF
Location	Main building.

Location Ref	
Element/Sub Element	24
Element ID	Electrical Systems and Equipment
Condition Grade (A-D)	C
Priority (1-4)	3
Description	Electrical distribution.
Defect	Existing distribution at full capacity and non-compliant with current standards.
Consequence of Inaction / Remedy	Power outages likely. Plan to replace and re wire circuits.
Target Year	01/11/2024
Residual Life	
Approx. Quantity	1
Unit	Estimated
Rate	6000
Cyclical	
Period	
Period Type	
Estimated Cost	6000
Risk Rating	Amber
